# TO THE CHANCELLOR OF THE DIOCESE OF ST ALBANS

## **Holy Trinity Church, Bengeo**

## **Summary Report for Cleaning Trials**

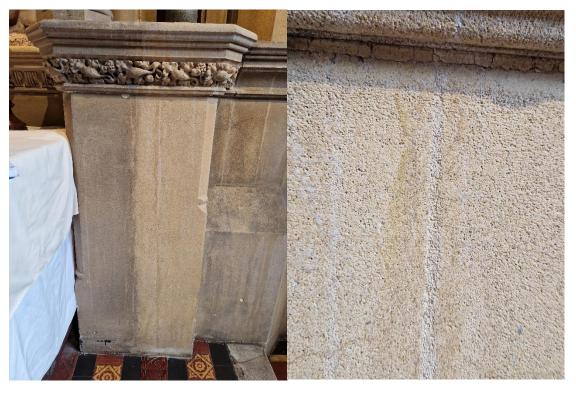
· Vertical run-off lines of accumulated condensation moisture is present upon much of the lower dado level ashlar masonry detailing through absorption of the low acidity moisture. These lines are pitted due to the acidity, which also increases the porosity and partial dirt migration into the stone by dissolution of carbonates. (Figures 2 & 3). After cleaning, these

Figure 2. Cleaned right side of base.

Figure 3. Condensation run-off pitted corrosion.

lighter lines may be patinated with dilute casein/mineral pigment distemper to match surrounding patinas.

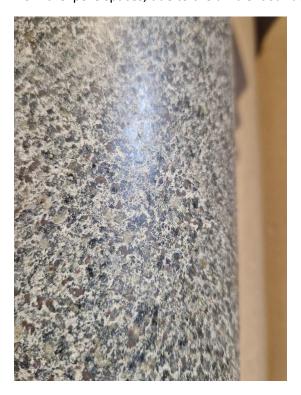
• The Purbeck Marble shafts have slight pitted corrosion which reduces the original high lustre polish. The softer micro-calcite binder between the harder crystalline mineral inclusions tend to precipitate from the pore spaces, due to the ambient surface condensation moisture deposits. (Figure 4).

Figure 4. Surface pitting to shafts.

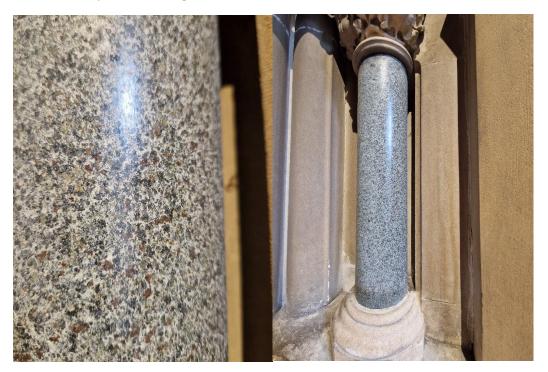
**Figure 5.** Renaissance wax sheen detail. **Figure 6.** Lustre upon buffed shaft.

A Renaissance wax was applied after cleaning to restore the lustre and colour, whist providing future condensation protection. (Figures 5 & 6).

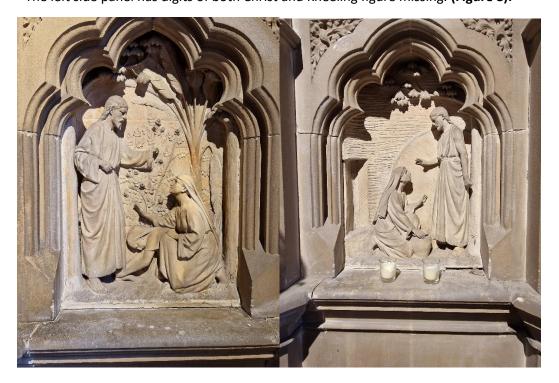
- The right-side terracotta relief panel has losses to the hand of Christ and thumb of the kneeling figure. (Figure 7).
- The left side panel has digits of both Christ and Kneeling figure missing. (Figure 8).

Figure 7. Right side panel.

Figure 8. Left side panel.

These losses may be repaired and re-integrated by a mixture of mortar repairs and moulding/casting of selected detailing.

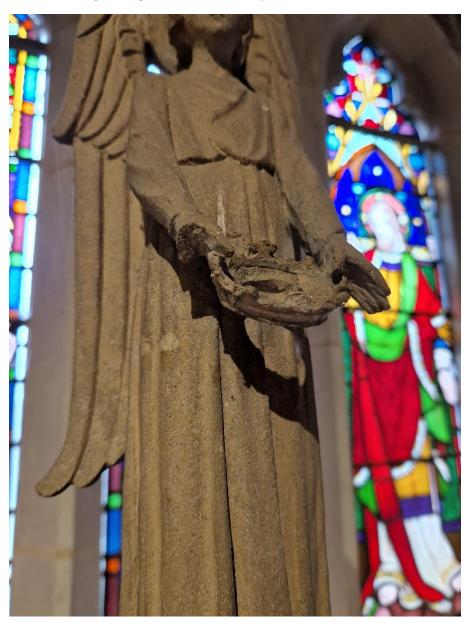
The left side figure (Figure 9), has loses to part of the left hand and front central detail of the crown.

Figure 9. Losses to angel detailing.

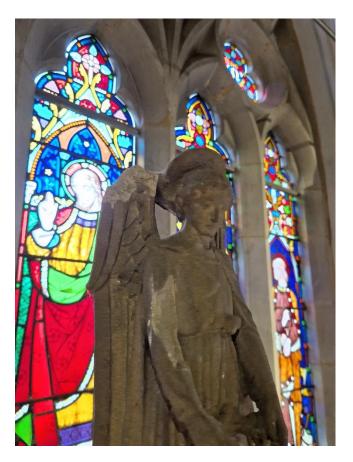
The second figure from the left shows part of the left bicep area missing, the upper left wingtip, and part of the bud-finial right side. (Figures 10,11).

Figure 10. Losses to upper arm and wingtip.

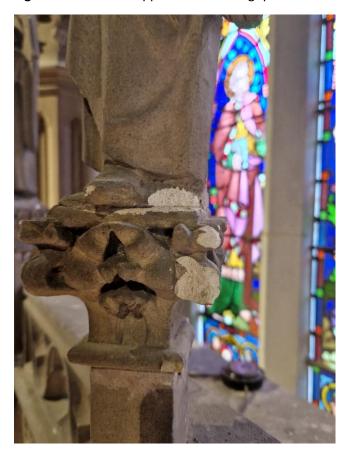
Figure 11. Damage to finial bud.

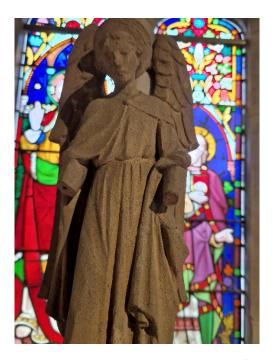
The third figure from the left reveals loss to both forearms . (Figure 12).

Figure 12. Forearm losses, with dowel fixing holes .

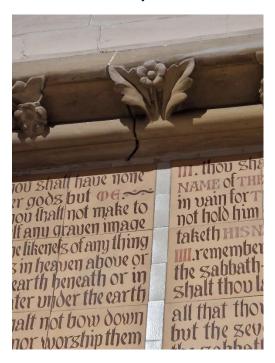
• Pointing to joints has become dislodged due possibly to early rotational settlement/deflection. Figure 13 illustrates this to a joint line and shear movement above the left side inscription panel. (Figure 13).

Figure 13. Fissure and pointing loss to left niche panel.

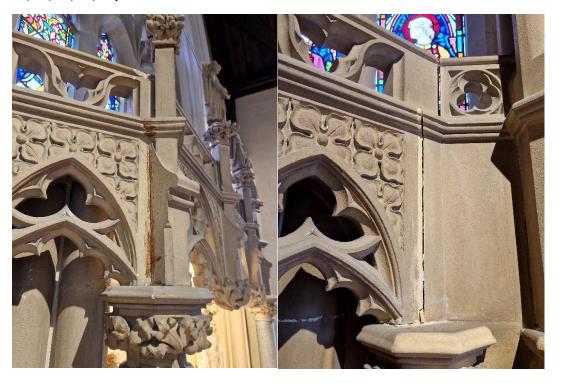
Figure 14. Figure 15.

Localised pointing losses or disruption has occurred to horizontal and perpendicular joints. (Figures 14, 15, 16, 17, 18, 19).

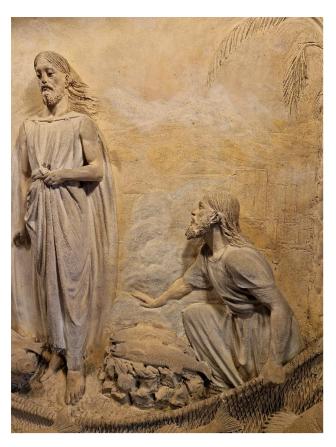
• The condition of the terracotta panels is good and sound. Surface and condensation fixed dirt have tended to remain adsorbed onto the surfaces, primarily to upper-facing detailing. The artisan-craftsperson have manufactured the surface using fired slip colours of light ochre, pale red terracotta and deeper red ochre terracotta, modulated in such a way as to distinguish space in the landscape, figures, architecture, clouds, and atmosphere. (Figures 20, 21).

Figure 20. Range of nuanced fired slip patinas.

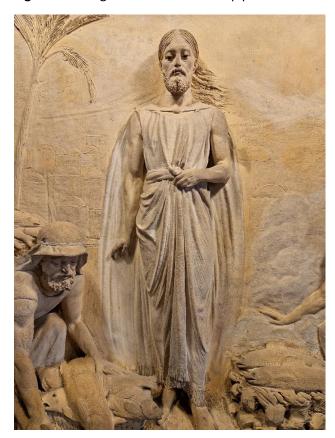
Figure 21. Detail of central Christ figure.
